Area : Garioch

Parish : Midmar

Kirkyard : Midmar old Parish Kirk.

Date of visit : 07/07/98.

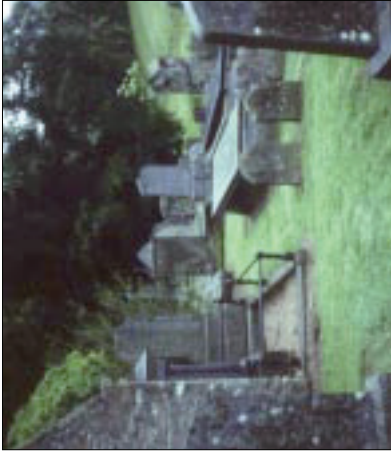
The Old Kirk : The old kirk was built in 1677, though today it is a neglected roofless ruin. Dedicated to St. Nidan, the long and low rubble built kirk, with the stump of a bellcote on the W. gable and a highly unusual quadripartite E. gable window, is in a deplorable state of decay.

There are many cracks in the gables and walls with trees growing from the wall-heads. The entire structure must be re-pointed urgently.

The kirk and yard are in a deplorable state of decay with the kirk requiring urgent remedial attention throughout to remove the trees and weeds prior to being stabilised. (See flaws listed above.)

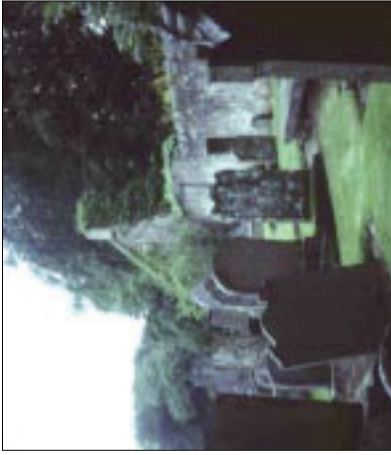
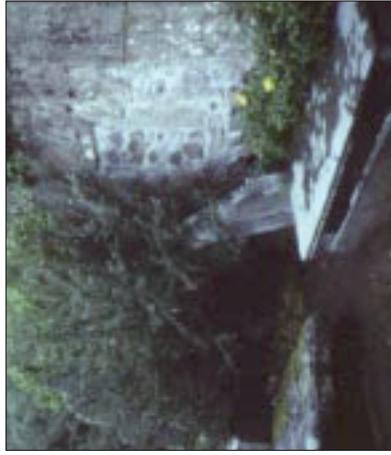
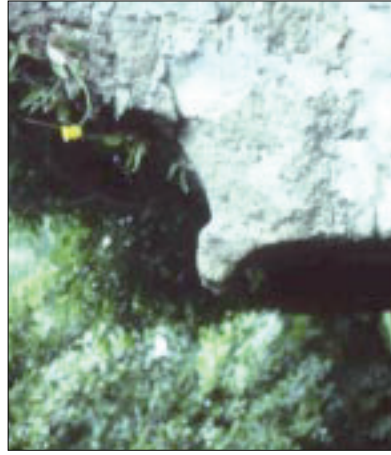
Tombstones : There are 22 recumbent tombstones of which 5 are particularly well decorated, with over one hundred upright tombstones from the 16th - century onwards. There are a great number of well designed and interesting memorials though many are in a terrible state of disruption, vandalism and neglect. This yard is the resting place of George Bell,

There are many tombstones of good quality that are terribly neglected and need urgent individual attention.
