Area: Kincardine and Mearns
Parish : Fetteresso
Kirkyard : St. Ciaran's Kirk.
 work being carried out to ensure their stability. Internally the kirk contains a superb white marble tombstone to the memory of Rbt. Wilm. Duff of Fetteresso, dated 1834, and features a finely carved armorial panel in a good pediment. The memorial is in reasonably good condition.

N.G.R. : NO 852 856

Listing Category : Kirk, Yard and Walls

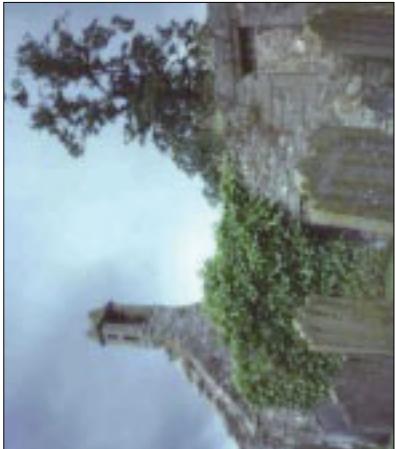
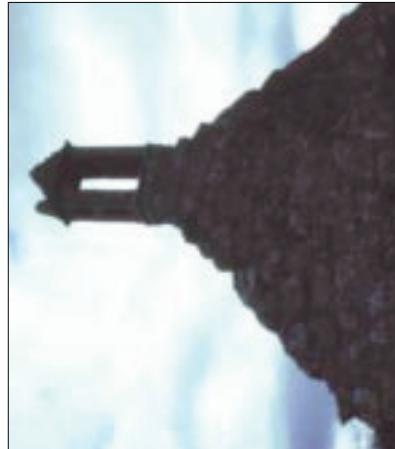
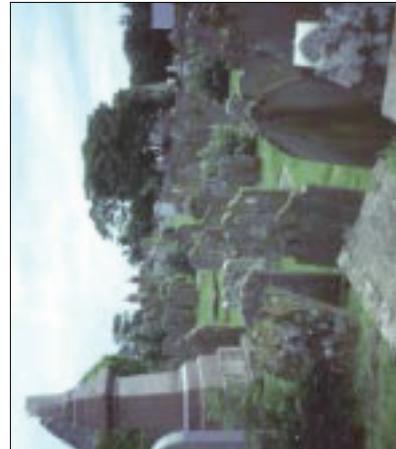
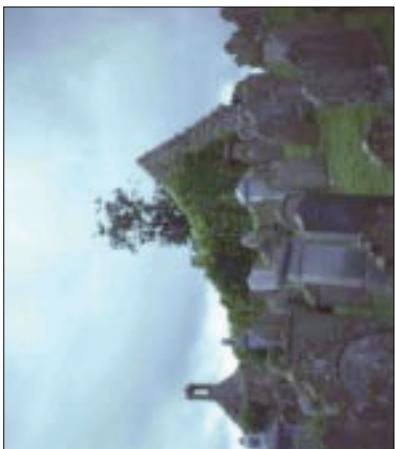
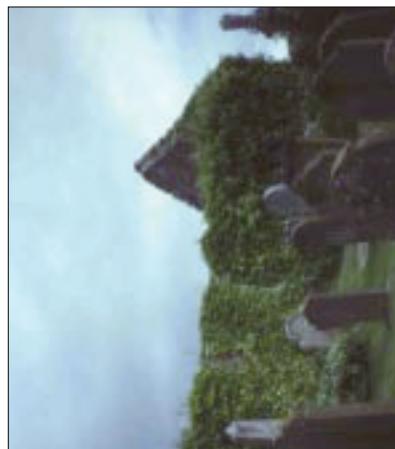
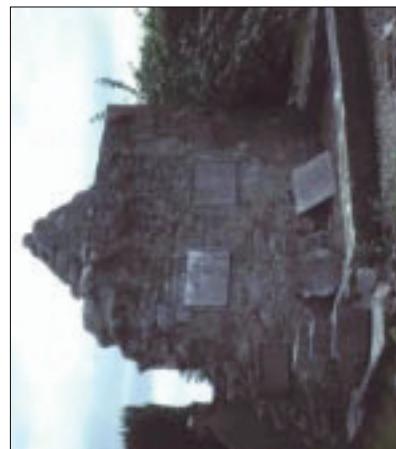
The entire S. elevation is covered in ivy which must be removed because of its detrimental effects on mortared joints and the structural stability of the stonework.

Internally this elevation can be seen to have contained a number of window and door openings; a thorough analysis of which would provide an insight into the functioning of the kirk. The N.W. gable of the kirk is crowned by a bellcote, dated 1737, though the bell is no longer present. This entire gable, as with the rest of the kirk, requires to be re-pointed throughout to ensure structural stability.

The N. projections of the kirk appear to be pulling away from the main body of the kirk and require a structural survey prior to remedial

There are a large number of sycamore saplings growing throughout the yard that must be removed soon as they pose a threat to the upright stones between which they grow.

The entire kirk must be stripped of all ivy to allow for a full assessment of structural stability prior to the building being re-pointed. One of the lintels on the S. wall is cracked and must be replaced. All the saplings must be removed from the yard.
