Area : Garioch

Parish : Inch

Kirkyard : St. Drostan's Kirk.

S.A.M. : Scheduled Ancient Monument.

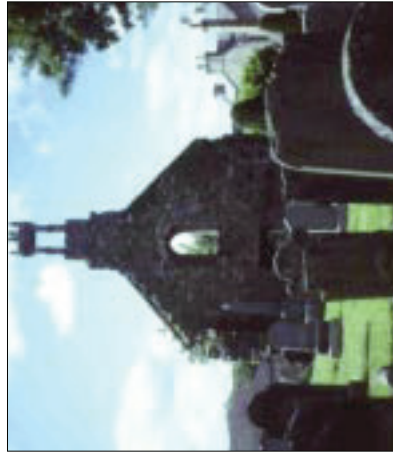
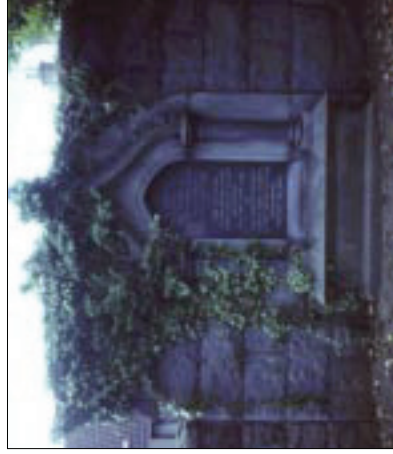
Boundary wall and gate piers : The gates and piers appear to be in good order though there are several cracks that need to be monitored on the rear boundary wall. There are numerous coping stones that have been pushed off the rear wall.

The gable and bellcote need to be checked by a structural engineer soon. All the recumbent stones need to be brushed, indeed two of them are already covered in turf. The cracks in the boundary wall need to be monitored and the cast-iron finials to the Daun memorial need to be reset on top of the monument before they are stolen. One finial appears to be missing and may have been taken or thrown over the boundary wall into the adjacent field.

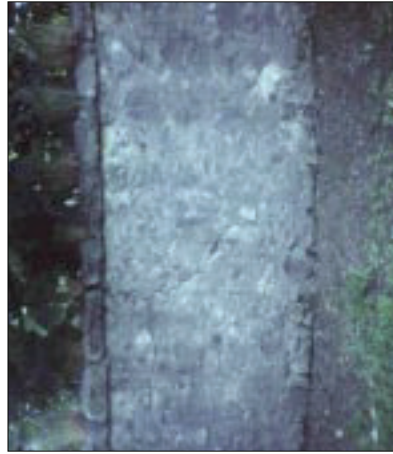
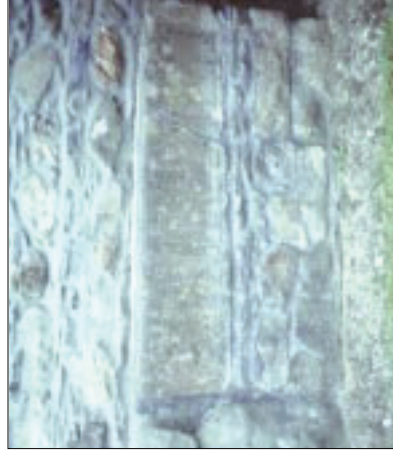
The Old Kirk : All that remains of the old kirk of Inch, said to be gifted to the Abbey of Lindores before 1195, is the W. gable complete with a stunning example of a 17th - century pedimented bellcote. One stone lintel of the 1613 bellcote is cracked and weathering badly which will affect the stability of the entire belfry. The doorway opening in the gable has a cracked granite lintel, and four aesthetically unsuitable steel lintels behind, which must be replaced in the fullness of time with stone or good quality sandstone lintels. All the weeds must be removed from the wall before the crack in the r.h.s. of the interior of the gable can be picked out and re-pointed. There is a well-carved skewputt initialled and dated AR / 62 on the S. side of the gable.

The "tooth-paste" render on the gable wall returns must be avoided.

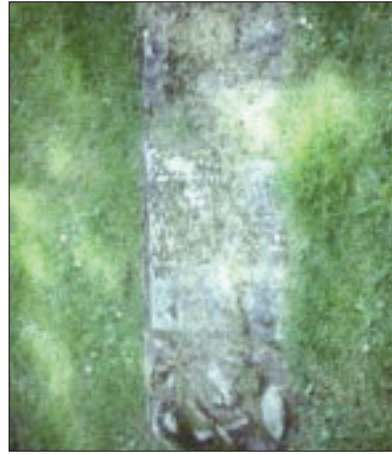
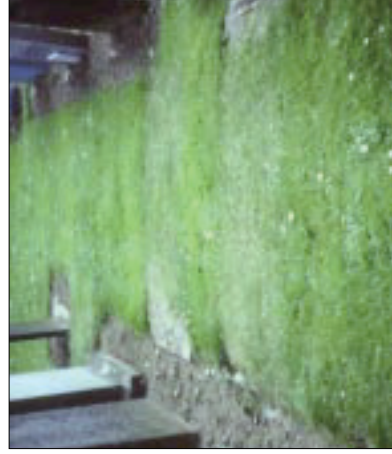
Early Features : In front of the gable lies the Radulfus stone, an incised stone probably commemorating Radulfus, Chaplain of the Bishop of Aberdeen between 1172 and 1194. The stone, a Scheduled Ancient Monument, is a simple rectangle incised with an inscription and a cross.

A badly eroded half of a figure statue lies beside the tombstone.
